STRESS CORROSION CRACKING
OF AUSTENITIC STAINLESS STEELS

A THESIS

In Partial Fulfillment
of the Requirements for the Degree
Doctor of Philosophy
in the School of Chemical Engineering

December, 1970

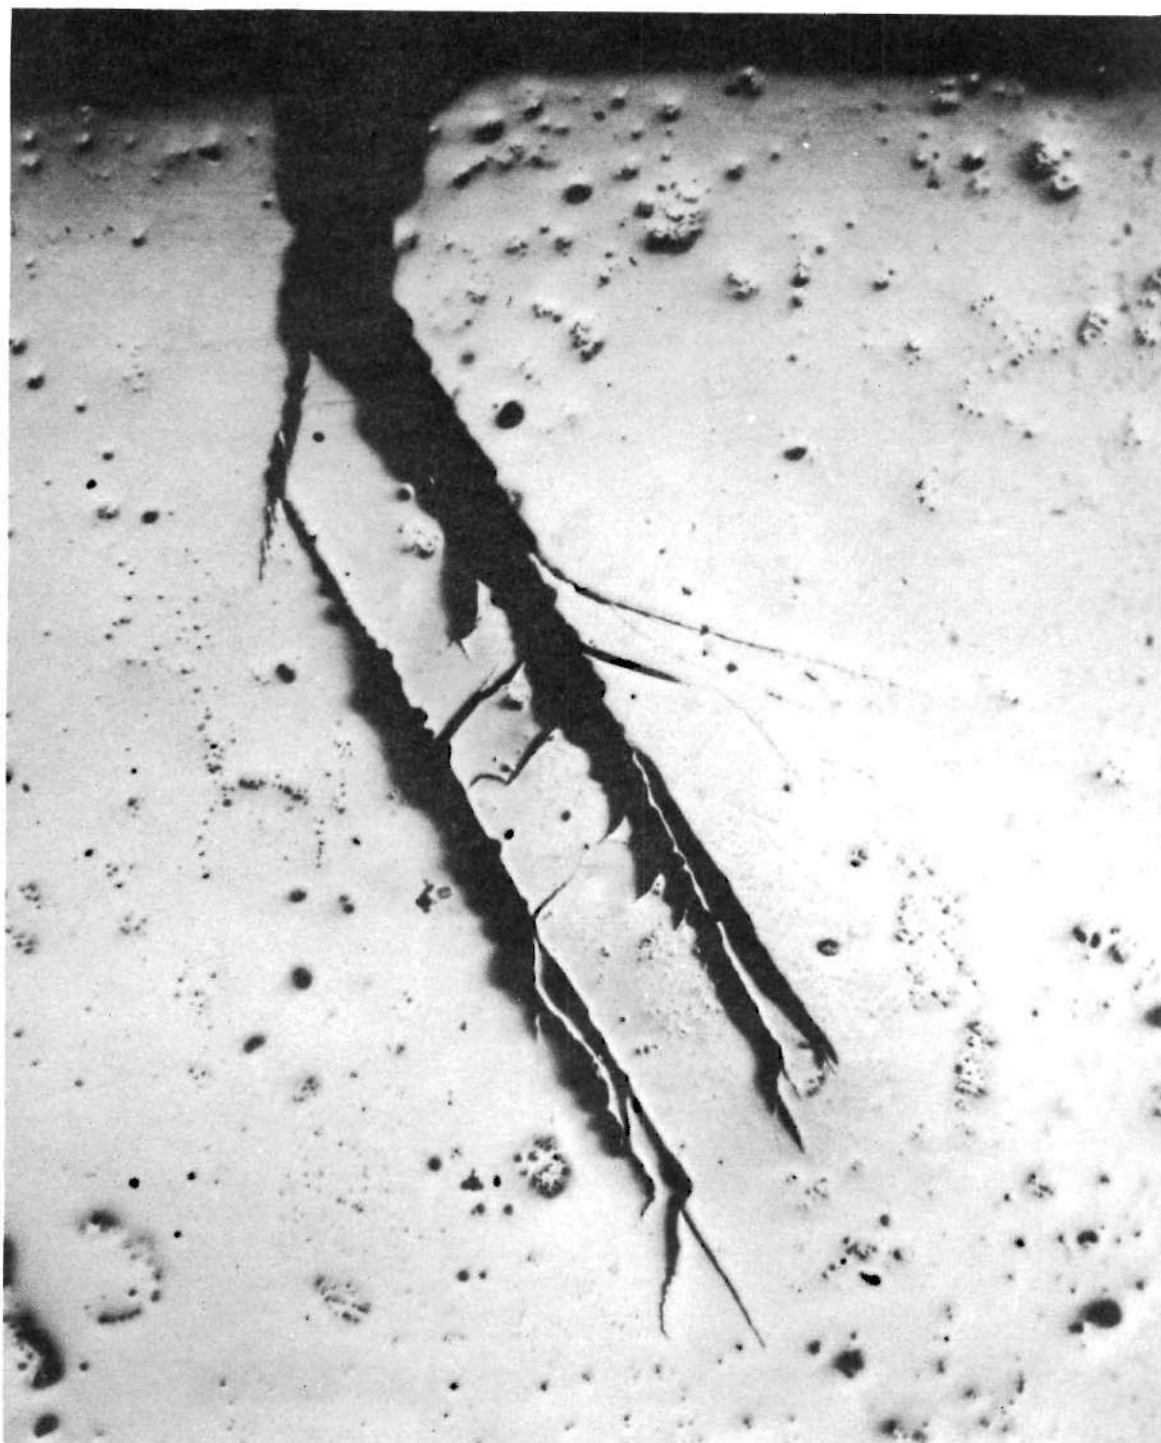
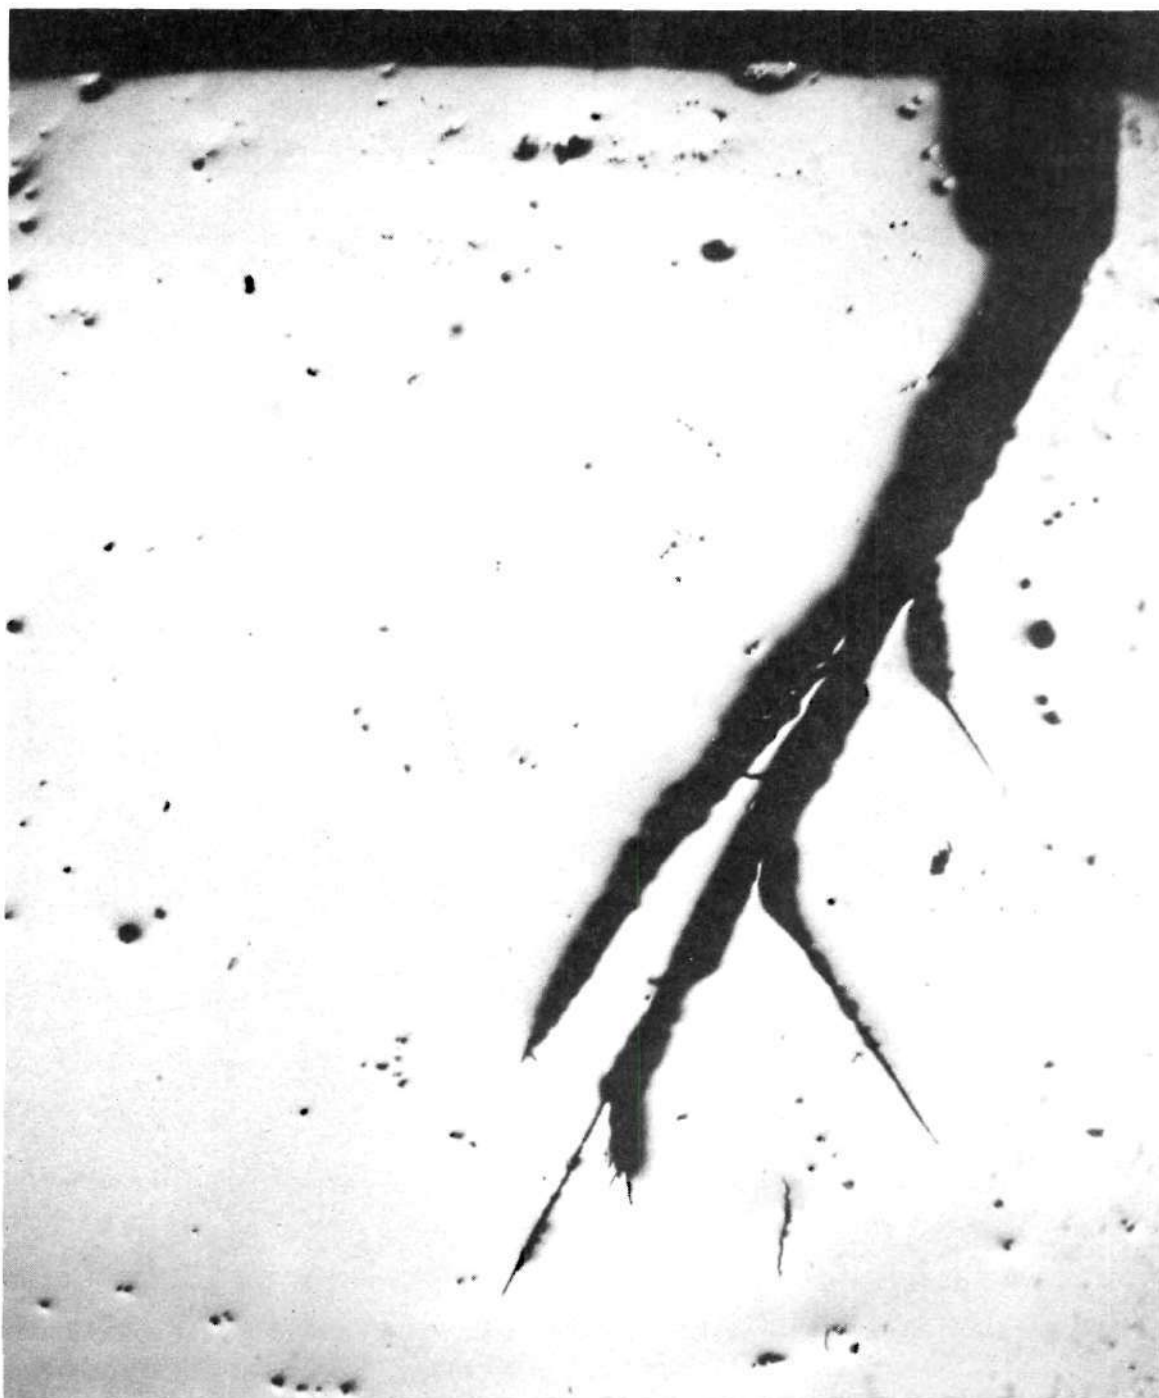
Figure 14. Traces of Stress Corrosion Cracks on Sides of Single Crystal Specimens; $(1\bar{1}0)$ Surface: (a) Specimen B3 (Magnification 50x).

Figure 14. (continued) Traces of Stress Corrosion Cracks on Sides of Single Crystal Specimens; $(1\bar{1}0)$ Surface: (b) Specimen B4 (Magnification 50x).

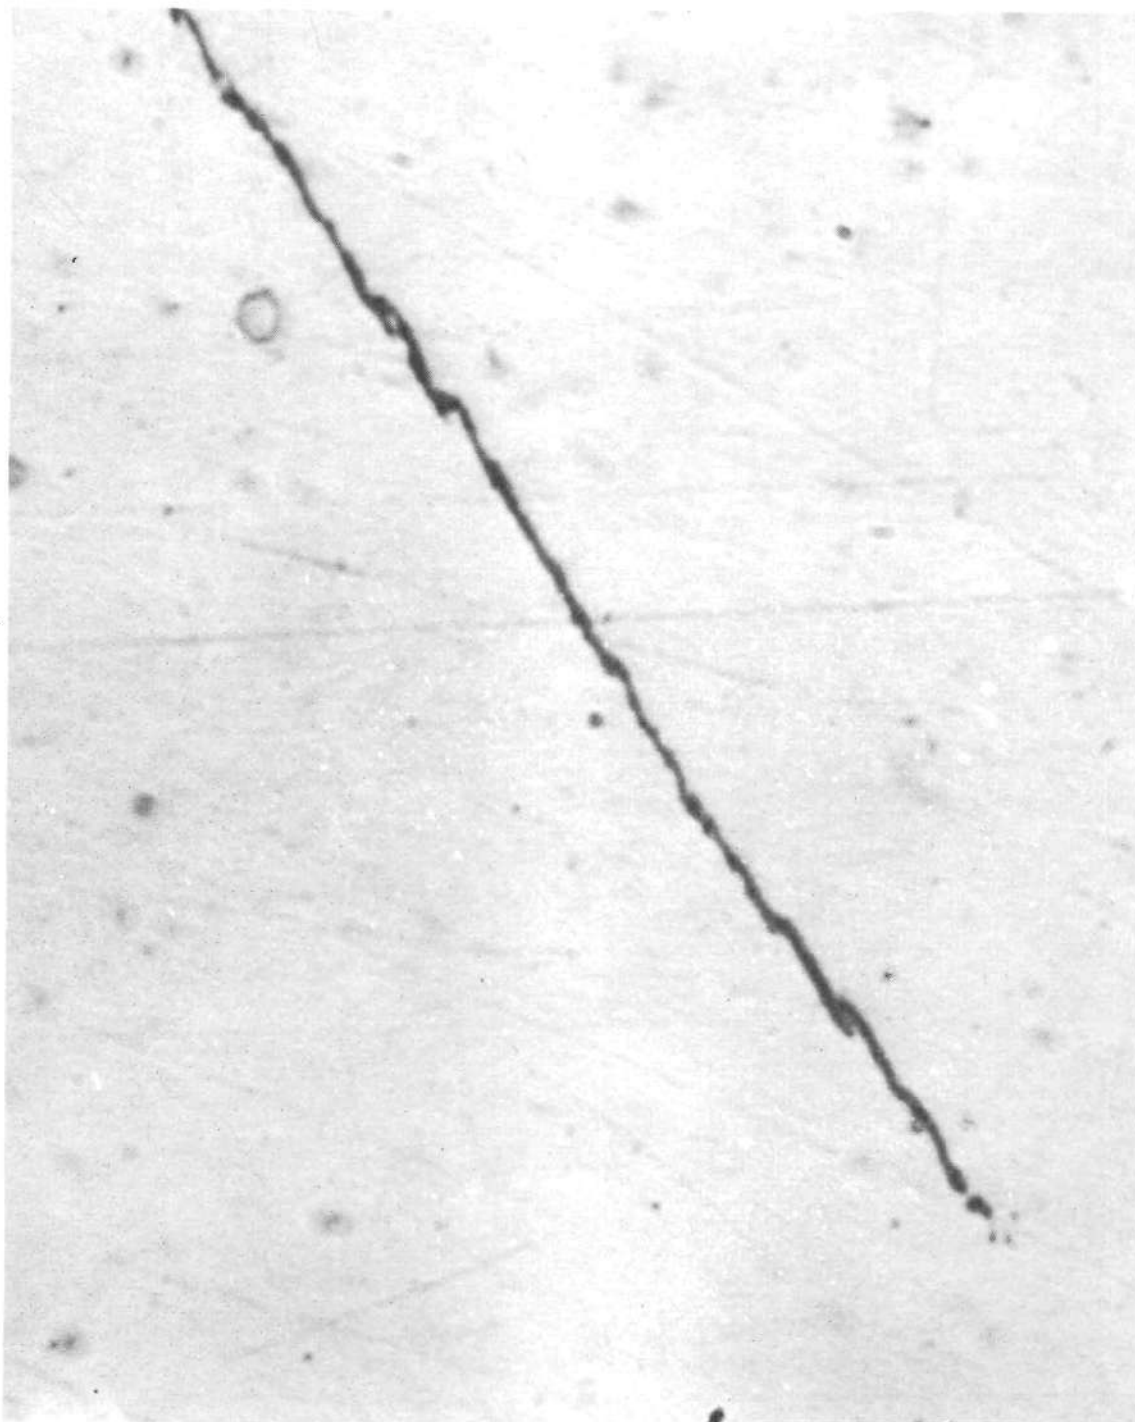
Figure 22. End of Crack Trace on the (112) Side of Specimen C1;
Optical Micrograph (Surface lightly polished and etched,
Magnification 2,200x).

that the trace is made of short segments, directions of many of them being consistent with the direction of the traces of $\{210\}$ planes.

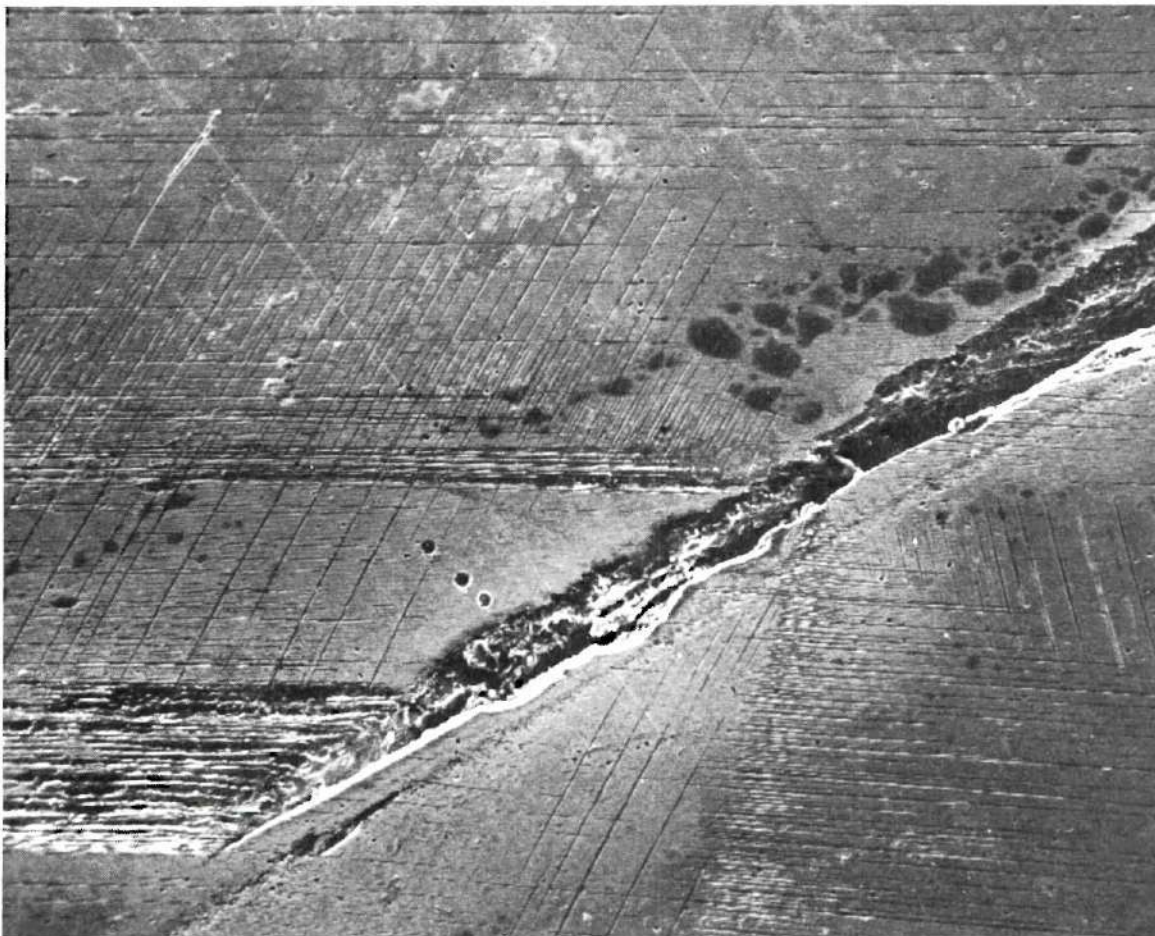
Figure 44. Corrosion Attack on Slip Lines along a Crack. Specimen X2 (unnotched), Narrow Side. Scanning Electron Micrograph (Magnification 190x).
